## Concrete Journal, Vol.50, No.4, Apr. 2012

## Status report on damages of bridges and management efforts in Kagawa prefecture municipalities

Teiji OTA\*

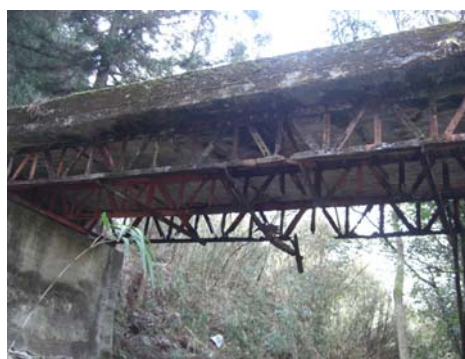
In 2007, a truss bridge fell down in Higashikagawa City in Kagawa Prefecture. Photo 1 is an image of the bridge before removed. The fracture of its truss lower chord member obviously shows that no maintenance had been done on this bridge. This accident triggered my doubts about the safety of the bridges managed by municipalities.

Photo 1 Truss bridge which fell down in 2007

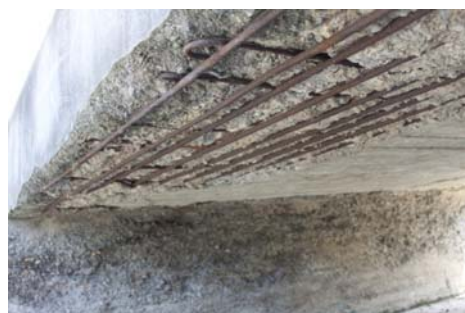
Photo 2 shows a slab bridge damaged due to concrete neutralization. The concrete has felt away and some reinforcing bars are exposed. This bridge is in front of the side gate of a junior high school and students cross it in the morning and afternoon. It is not the civil engineering division but the education board that manages this bridge, and I am afraid that the current state of the bridge is not properly reported to the board.

Photo 2 Slab bridge damaged due to concrete neutralization

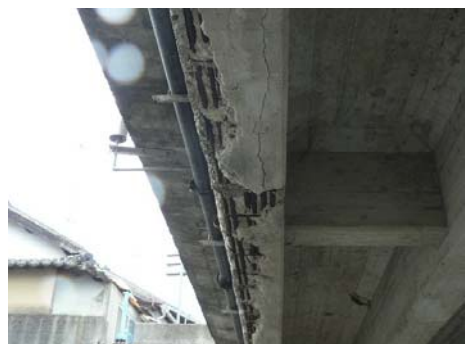
Photo 3 is a RCT-beam bridge with salt damage in Shodoshima Island. At the time of construction, the concrete was not adequately distributed throughout the beams due to densely-arranged reinforcing bars, and strong sea winds corroded the rebars.

Photo 3 RCT-beam bridge with salt damage
